# IMPLEMENTING THE MARY RIVER & TRIBUTARIES REHABILITATION PLAN

## MONITORING & EVALUATION REPORT 2003

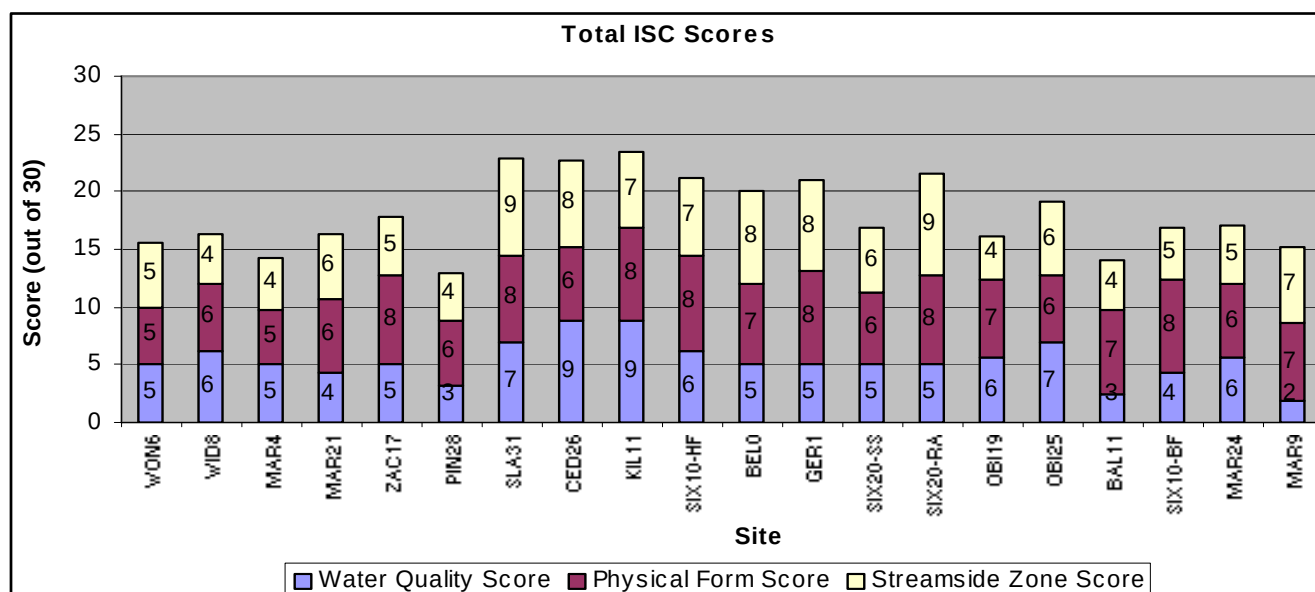
Figure 3.3

The total ISC score for each of the monitoring sites is shown in Figure 3.3. The three sections of each bar represent the three components of the ISC. The variety of resulting ISC scores, ranging from 14 to 23, indicate that the sites monitored were in various stages of degradation.

The ISC scores of the SIX20-SS site and SIX20-RA (see figure 3.3) may also be used as an example of effectiveness for the COG scores. The SIX20-SS site, which scored a 7 out of 45, represented a monoculture of pasture grass, while the SIX20-RA scored 31 out of 45 was predominately well-established natural regeneration, with a high level of species diversity.

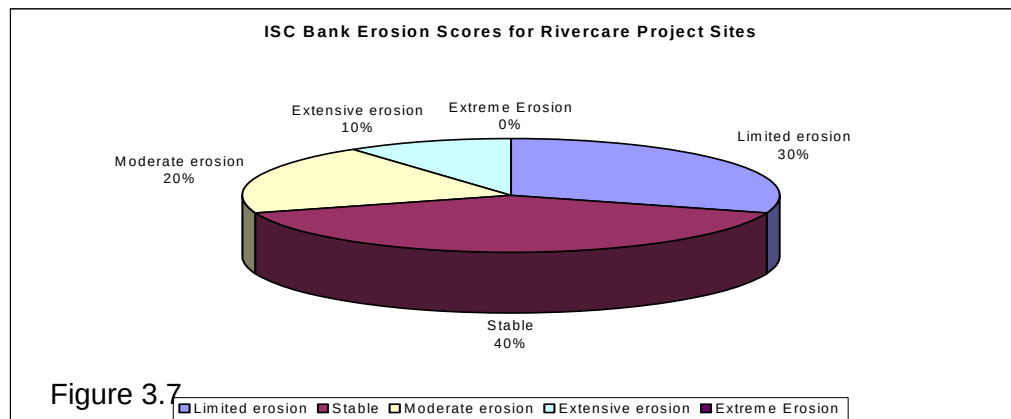
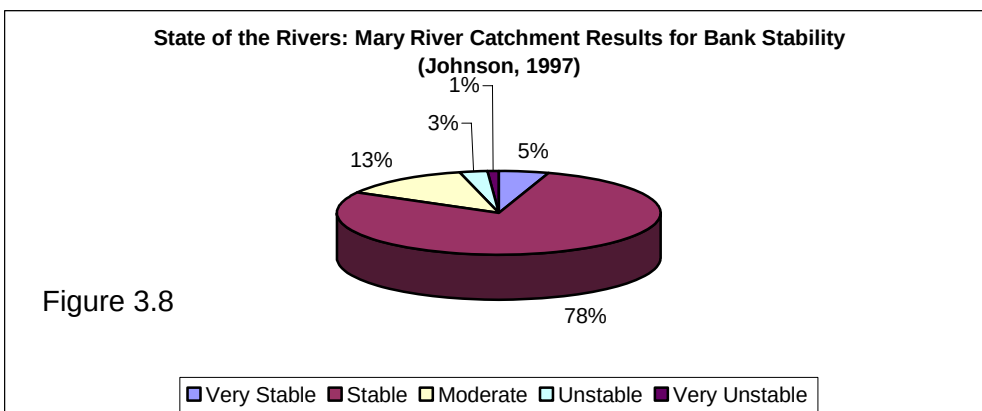
Figure 3.7 reveals that the overall bank stability of the sites is in fair condition, with 40% classed as stable and 30% recorded as having only limited erosion. None of the sites obtained a score of '0' (extreme erosion). When comparing

these overall results to the Mary River and Major Tributaries: State of the Rivers Report (1997) findings (see figure 3.8) it can be seen that while both exhibit similar results for the three higher levels of erosion, the State of the Rivers shows a greater percent of banks classed as stable, while the ISC monitoring has a far greater occurrence of banks with limited erosion and stable banks.

Observation showed that the bank erosion occurring was predominately scour erosion (removal of individual sediment particles or aggregates by flow. Mass failure (slumping) was noted on occasion. This was expected particularly in the lowland areas where bank height increased (Abernethy & Rutherford, 1999).

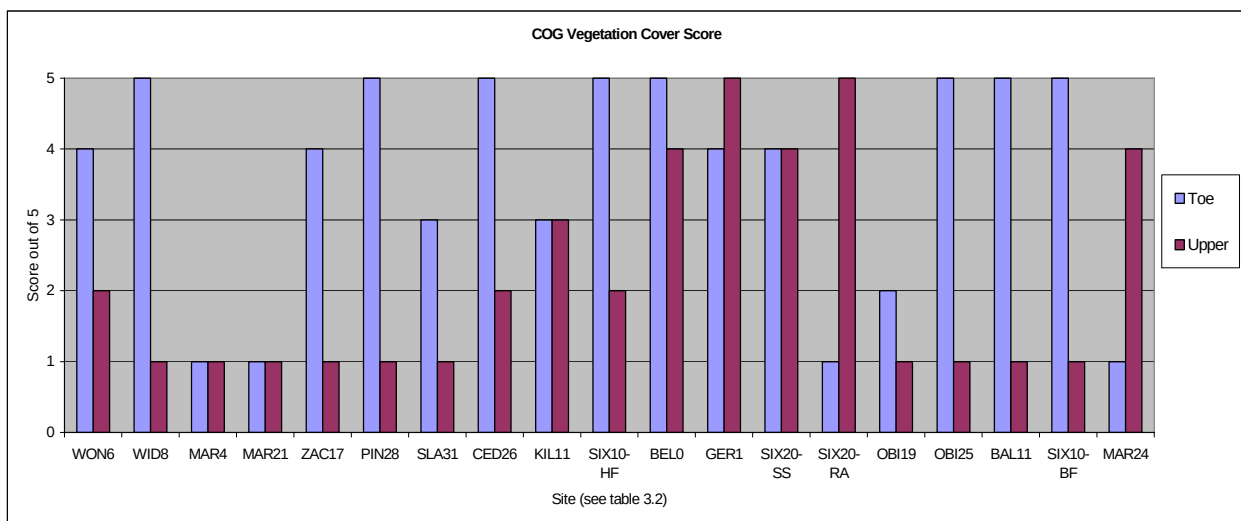
Figure 3.9 depicts the relationship between vegetation and bank position. It shows that for 12 sites the vegetation cover is higher at the toe of the bank, while only 3 sites exhibit a higher percent cover on the upper section of the bank. Four sites have equal cover at the toe and upper part of the bank. The definition of the top of the streamside zone used most often, that is to the change in land use, may explain the low percentages of vegetation cover on the upper bank sections. The upper transect was, in many cases, located within a strip of pasture grass which ran from the fence to the beginning of the riparian vegetation. The pasture strips averaged 7 meters wide.

It is apparent from Figure 3.9 that the vegetation cover scored well at the toe of the project sites banks. This may be viewed as a positive sign in terms of stream health as lack of shaded instream habitat is thought to be a major reason for the rarity or absence of the Mary River Cod in many areas (Simpson & Jackson, 1996). It may also be noted that while the over storey will have a large influence over the process of slumping erosion, shrubs and grasses are equally important for controlling scour erosion (Abernethy & Rutherford, 1999).

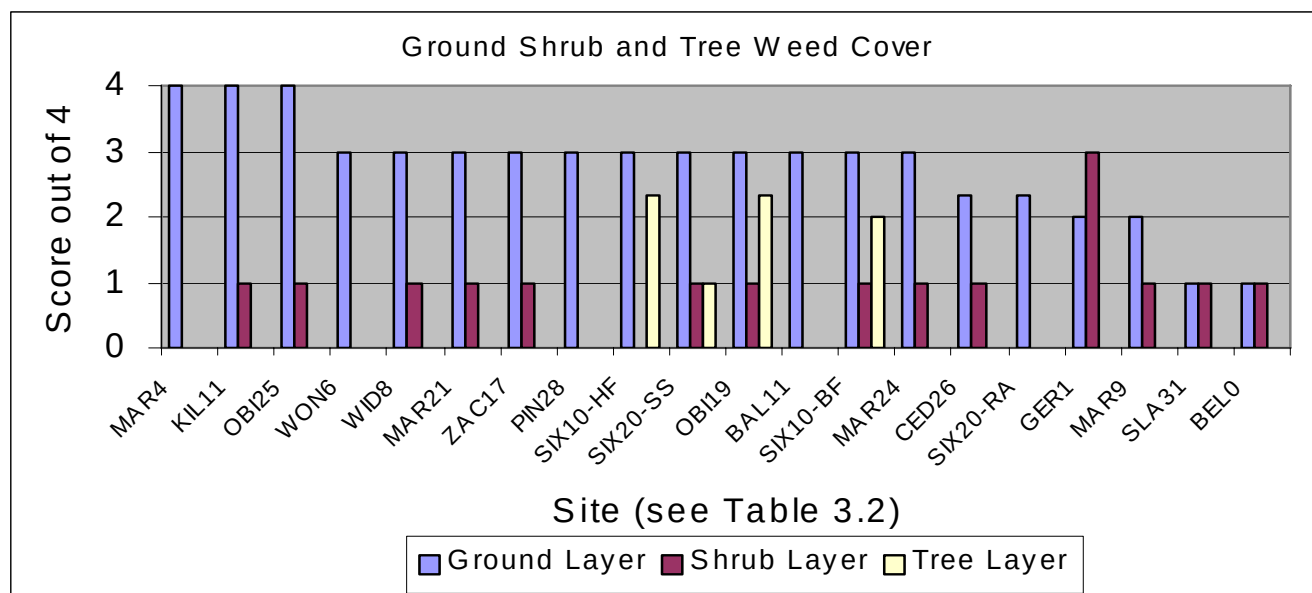
Figure 3.10

By viewing Table 3.7 and figure 3.10, it can be seen that the ground layer of weeds is identified as the most significant problem in terms of weed coverage of the riparian zone, while the tree layer is of least concern. As cattle have been removed from a significant number of sites, this may have a combined affect on the cover of ground weeds. Firstly certain weed species will no longer be suppressed by cattle grazing, and secondly the disturbed environment created by past cattle access often produces an ideal environment for weed invasion.

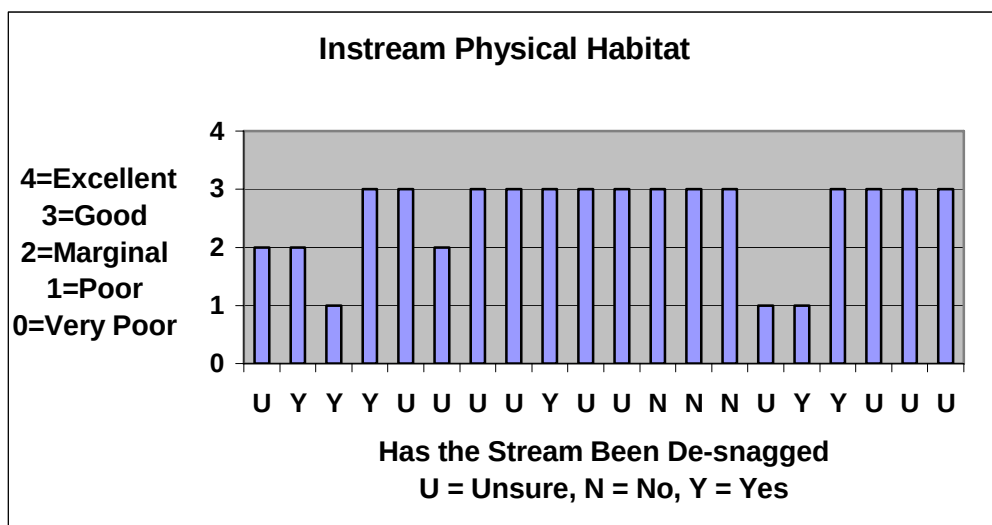
Figure 3.12

The results show that the majority of sites had “good” instream physical habitat. Radio tracking research on the Mary River Cod has revealed that 93 percent of all cod observations occurred within 2m of submerged timber (Simpson & Jackson 1996), suggesting that suitable woody debris habitat for cod is available at most of the sites monitored.
